PROBLEMS OF LANDSCAPE ARCHITECTURE
IN
THE NATIONAL FORESTS

REPORT TO U. S. FORESTER'S OFFICE
ON
TRIP OF INSPECTION THROUGH SOME OF THE NATIONAL FOREST AREAS
IN
REGIONS 2, 4, 6 AND 1

BY
A. D. TAYLOR
CONSULTING LANDSCAPE ARCHITECT
SEPTEMBER 1935

(July 26, 1935 through August 22, 1935)

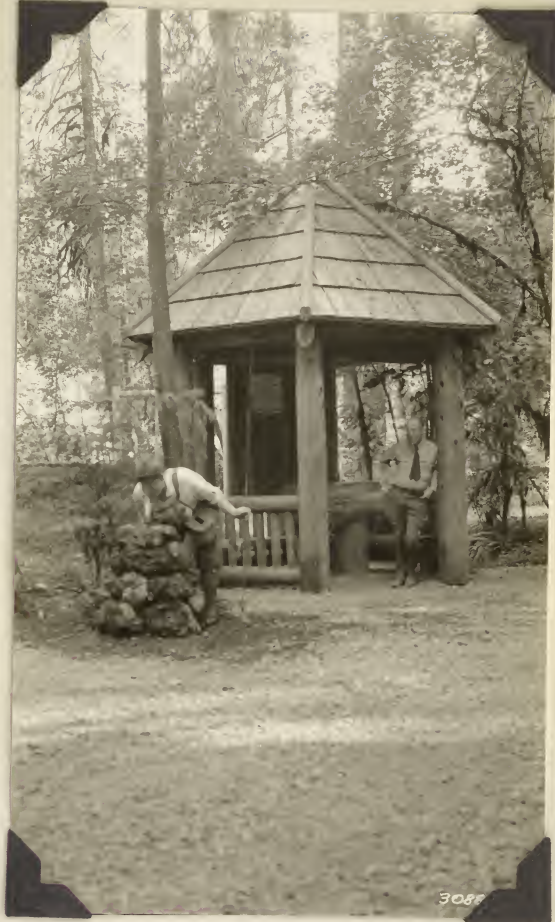
Willamette National Forest
McKenzie Bridge Forest Camp

View showing in detail a very interesting type of registering booth which contains a very unusual detail for holding the register.

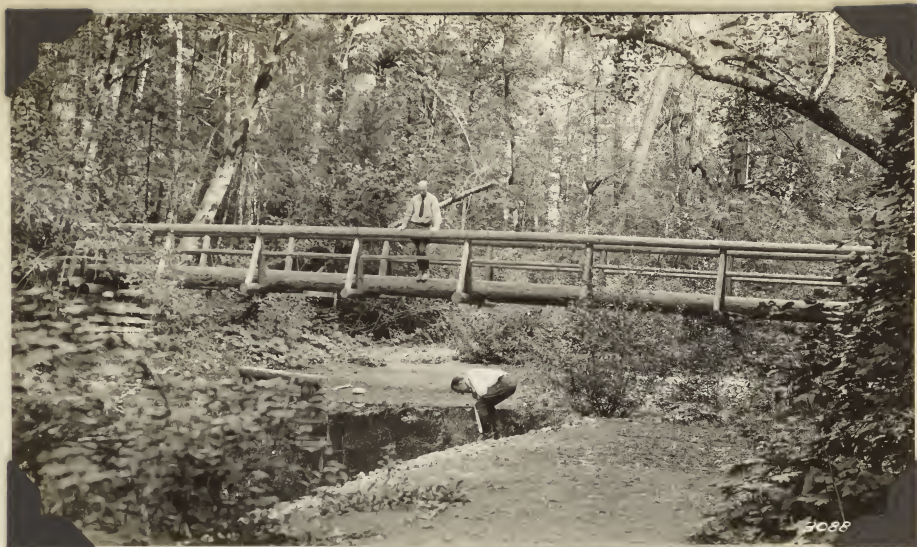
Willamette National Forest - McKenzie Bridge Forest Camp

Detail view of an interesting log bridge used for foot traffic across the river. This is an appropriate type of bridge for forest areas

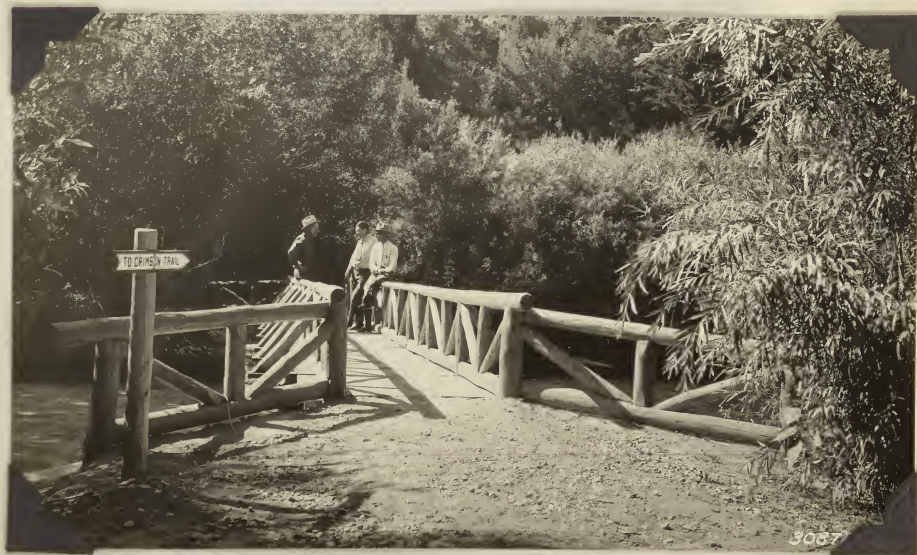
Cache National Forest - City Park Forest Camp in Logan Canyon

Detail view of a most interesting foot bridge constructed across the Logan River.

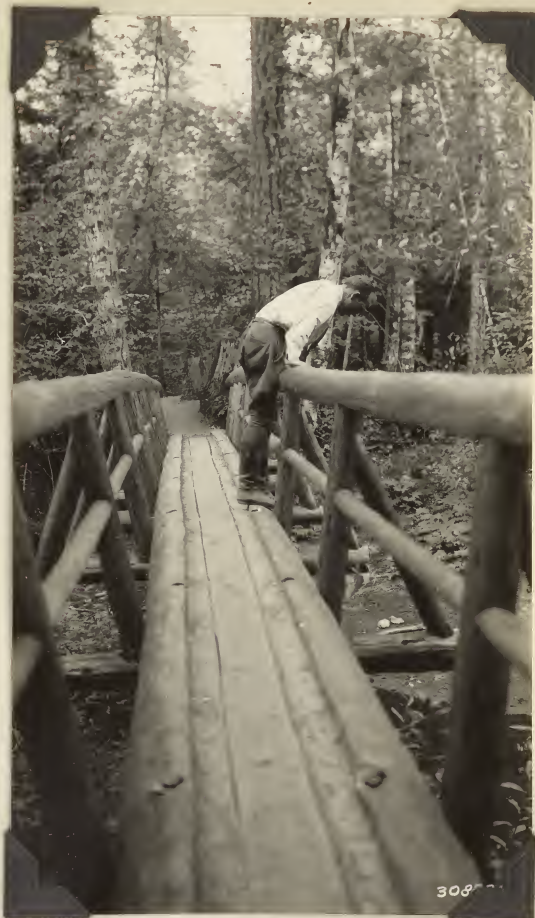
Willamette National Forest
McKenzie Bridge Forest Camp

Detail view looking along the axis of the bridge. Note the interesting type of hewn timber floor used in the construction of this bridge.

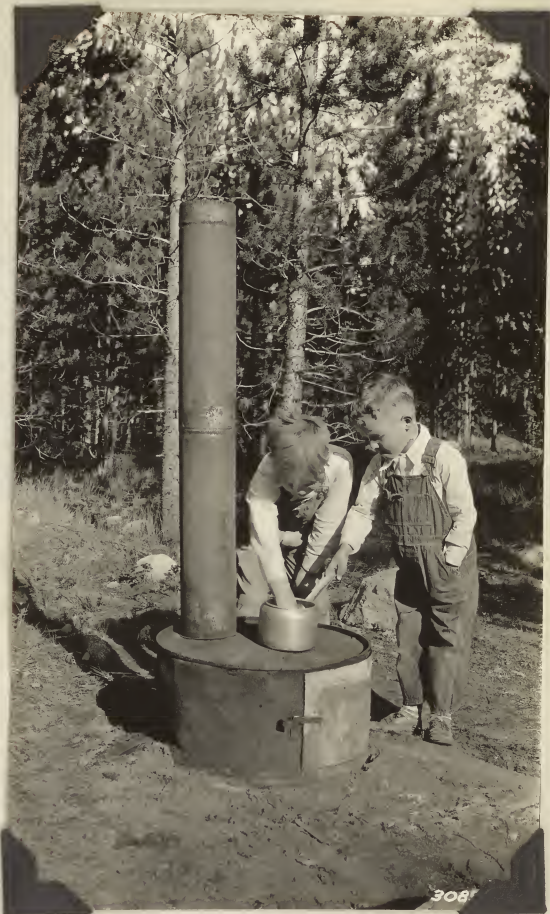
Deerlodge National Forest
Spring Hill Forest Camp

Detail view of a stove used in this area. This type of stove may be entirely practical for cooking, but it is a most distracting element to be located in the midst of a camp ground unit and its use should be discouraged. From my observation I do not think there is a practical method of "camouflaging" this stove with stone. There are a number of solutions for the appropriate design of a unit of this kind, so much more desirable than this feature.

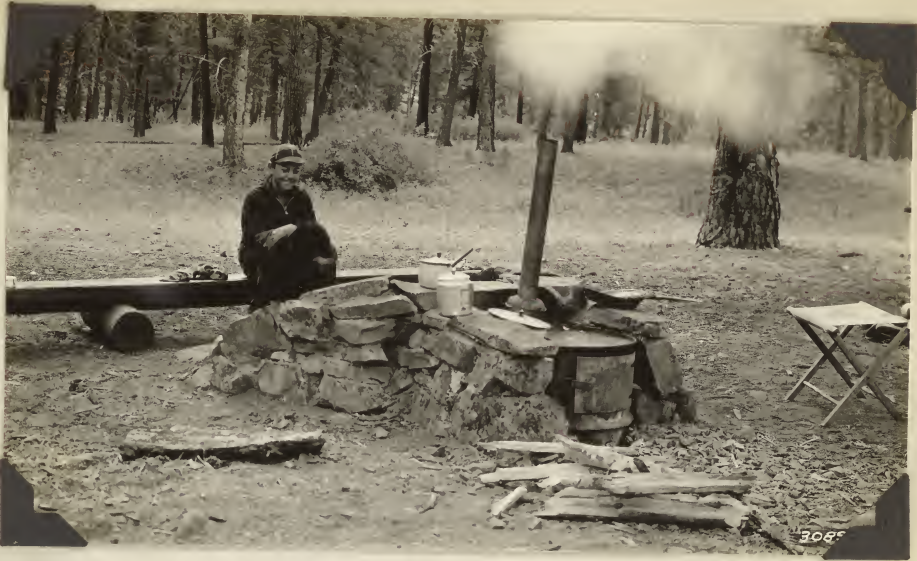
Lolo National Forest - Bitterroot Flats Forest Camp

Detail view of a camp stove. An effort has been made to informalize the stove by surrounding it with an unfortunate arrangement of stone.

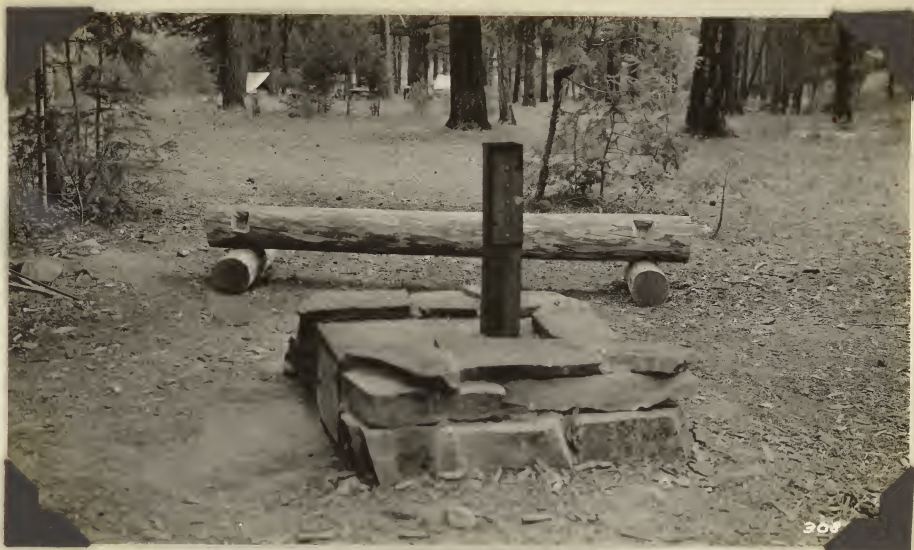
Lolo National Forest - Bitterroot Flats Forest Camp

Detail view of a camp stove. An effort has been made to improve the stove unit by surrounding it with stone.

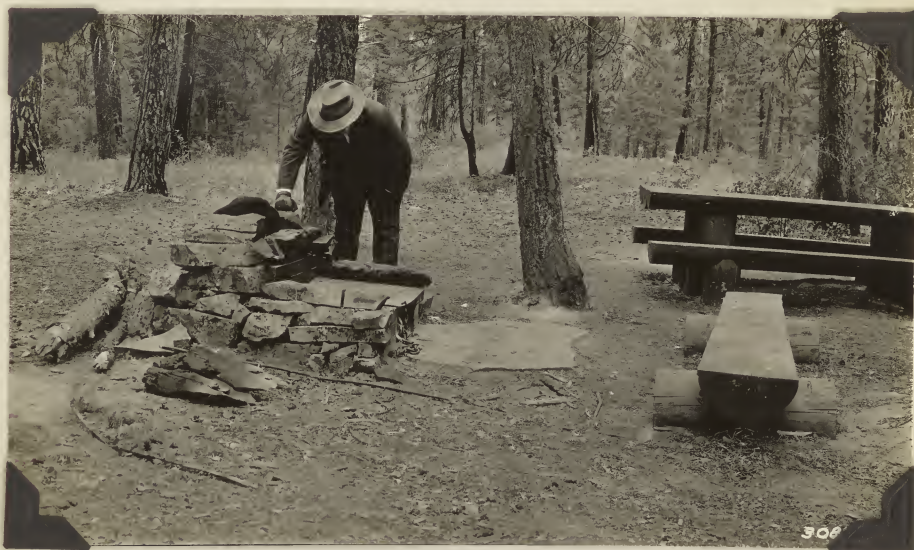
Deerlodge National Forest - Echo Lake Area

Detail view of a camp stove in use in the Echo Lake area. These camp stoves are not as attractive or as well constructed as they might be.

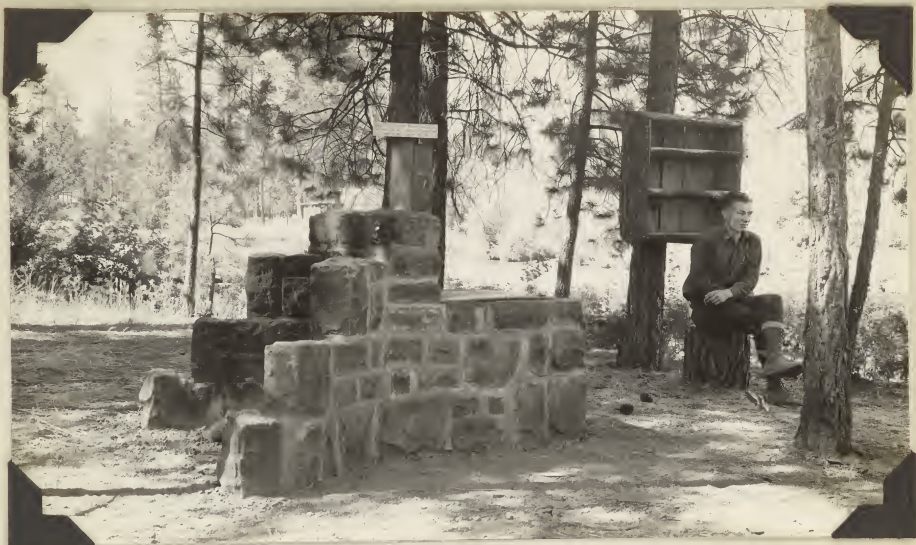
Deschutes National Forest - Metolius River Camp

Detail of a combination fireplace and picnic stove. Unfortunately the stove pipe chimney has not been properly camouflaged with stones, and it is a detracting element. The problem of providing cupboards in some camp ground areas is becoming acute. If cupboards are necessary they should be made as inconspicuous as possible.

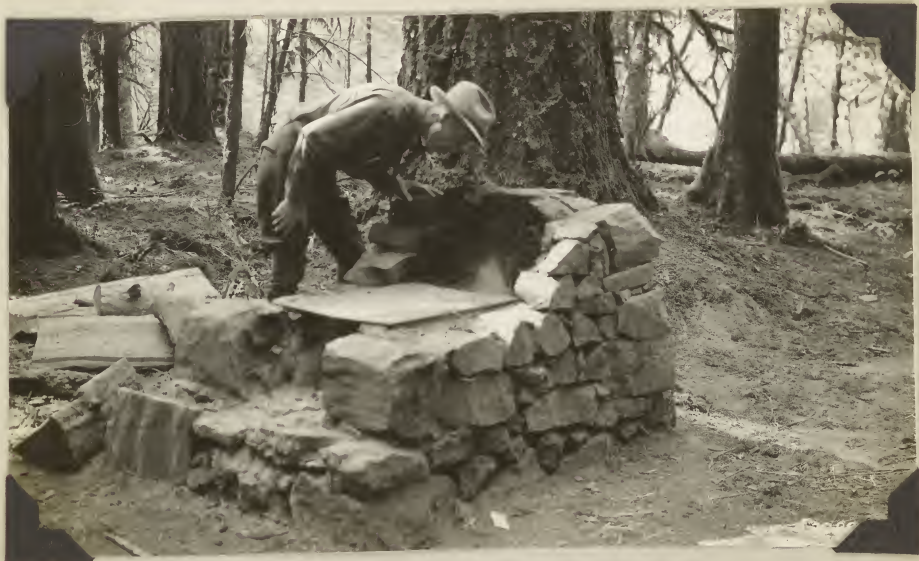
Columbia National Forest - Clear Fork Forest Camp

Detail of a camp stove used in this area. The texture of stone in this structure is not well done. This type of camp stove should be discouraged in favor of a stove similar to the one used in Siuslaw National Forest at Siltcoos Outlet Forest Camp.

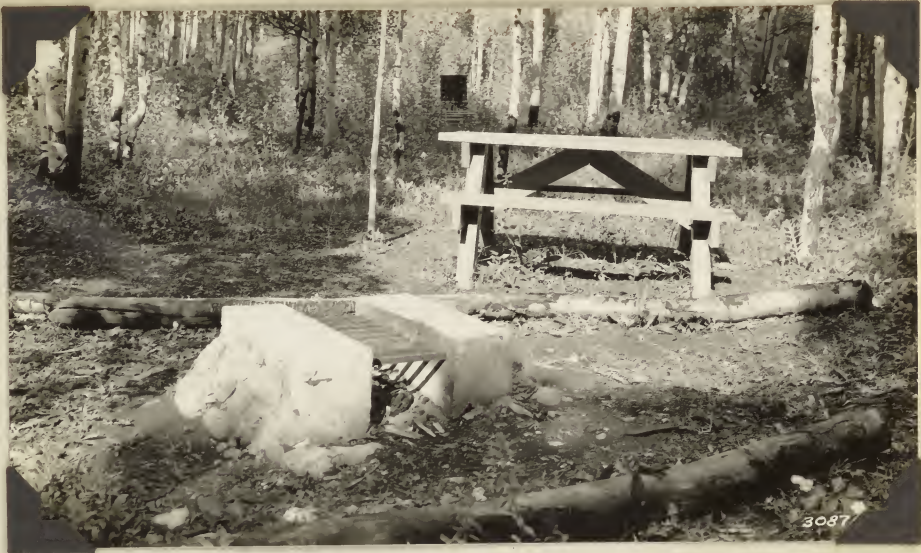
White River National Forest - Lost Creek Picnic Area

Detail of a fireplace and picnic table in use in this picnic area. Note the concrete construction in connection with the fire-place. This is not a desirable type of construction. Also note the natural cover of vegetation not yet destroyed.

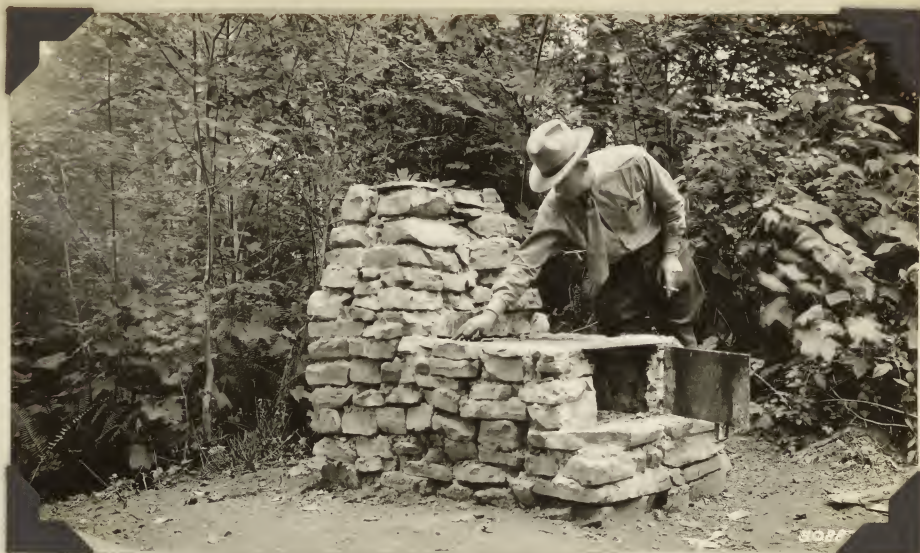
Olympic National Forest - Fall Creek Forest Camp

Detail of a camp stove with the door open. The stone work is very poor and the stove is not entirely practical because no provision is made for controlling the draft.

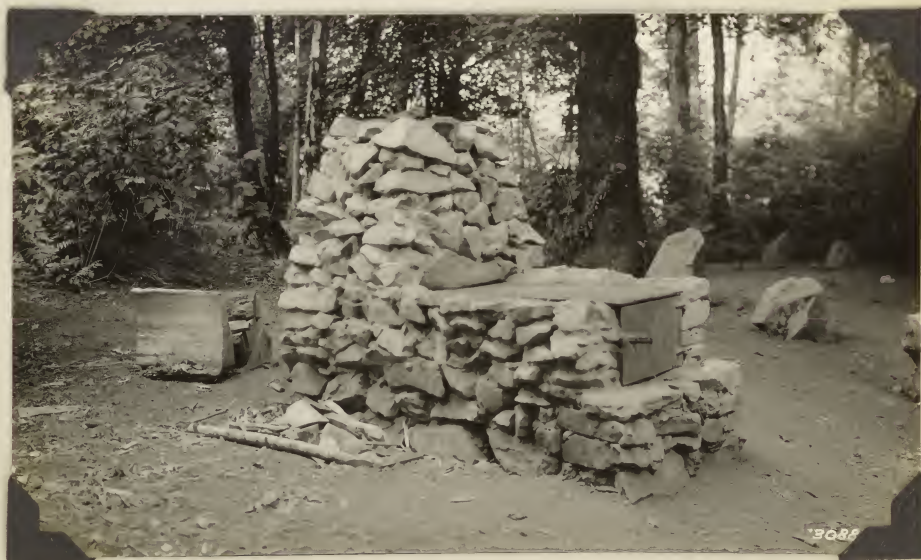
Olympic National Forest - Fall Creek Forest Camp

Detail of a camp stove with the door closed. This feature gives an appearance of "instability" because the texture of the stone work is very poorly done. The surface of the stone work is too rough, the texture gives the appearance of being too loose and the selection of individual stones has not produced a uniform effect.

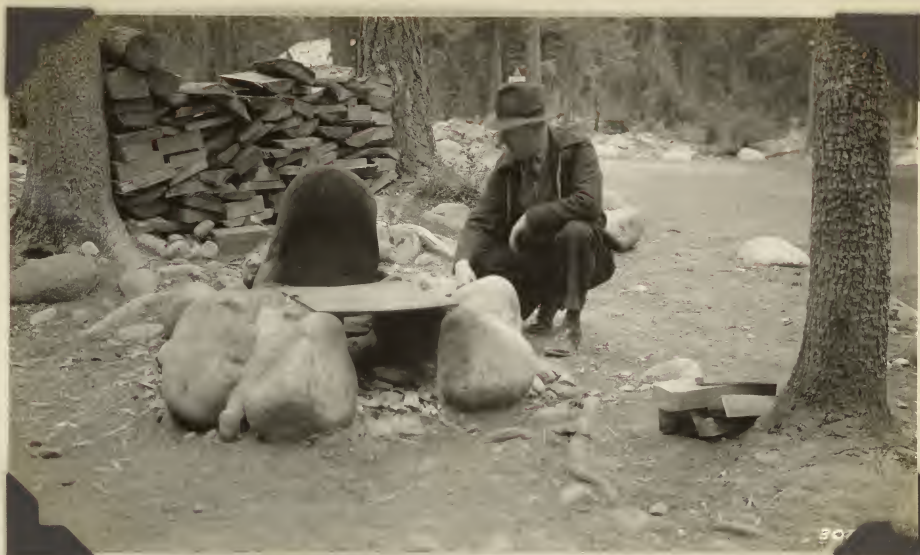
Rainier National Park - Forest Camp

Detail of new type of camp stove in use in this camp ground. Note the warping of the plate. This stove is not practical for camp ground or picnic areas.

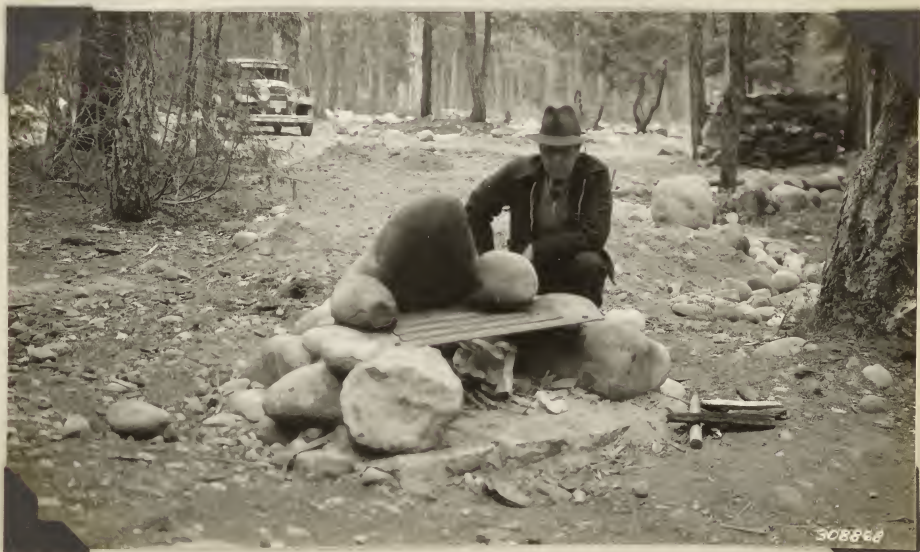
Rainier National Park - Forest Camp

Detail of the old type of camp ground stove. The grating is too low. This type of fireplace is not practical for camp ground use.

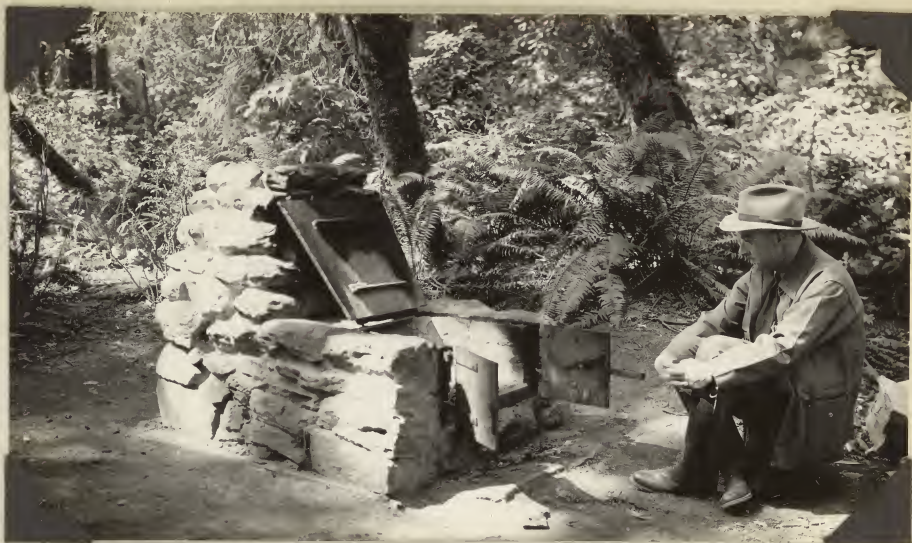
Siuslaw National Forest - Siltcoos Outlet Forest Camp

Detail view of a combination picnic oven and fireplace, showing the structure when used as a fireplace.

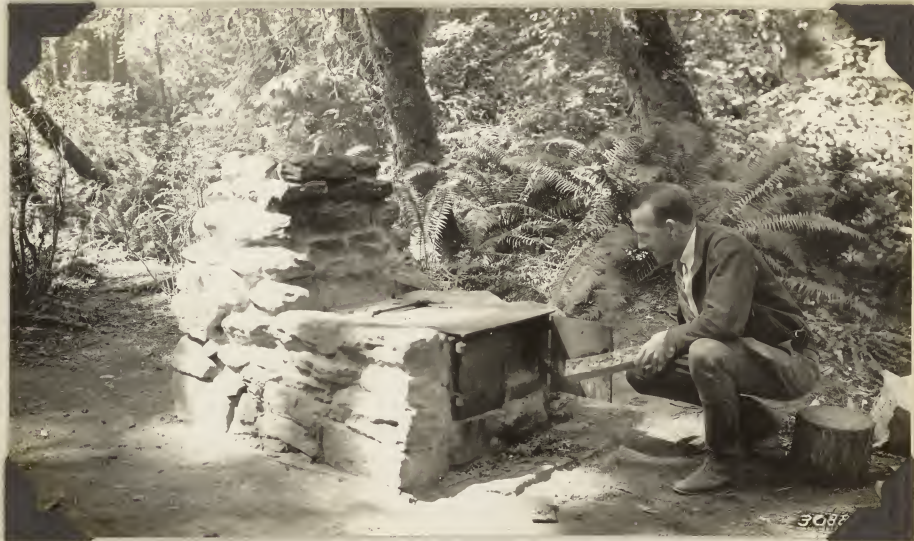
Siuslaw National Forest - Siltcoos Outlet Forest Camp

Detail view of a combination fireplace and picnic oven, showing the structure when used as an oven or stove.

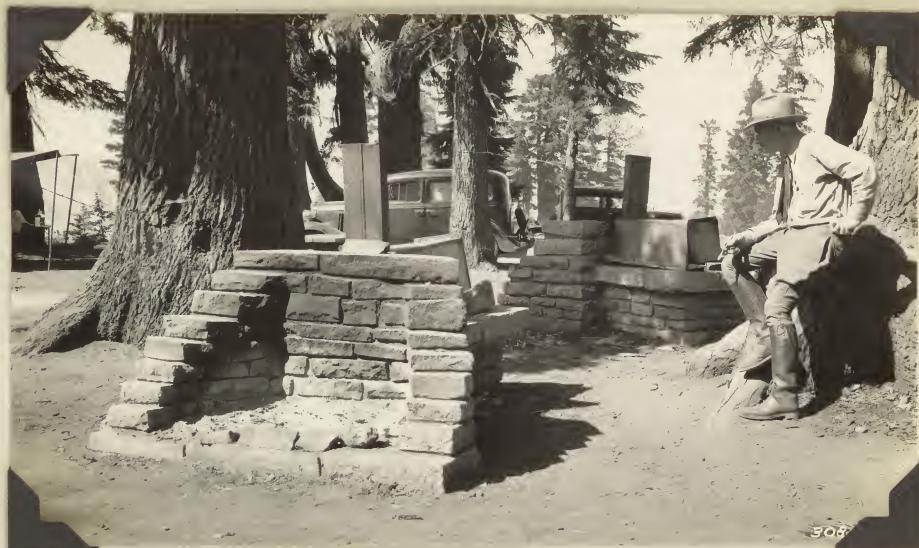
Crater Lake National Park - Camp Area

Detail photograph showing combination fireplace and camp stove now in use at Crater Lake. This type of picnic stove is not appropriate for camp use and I understand that it is being abandoned.

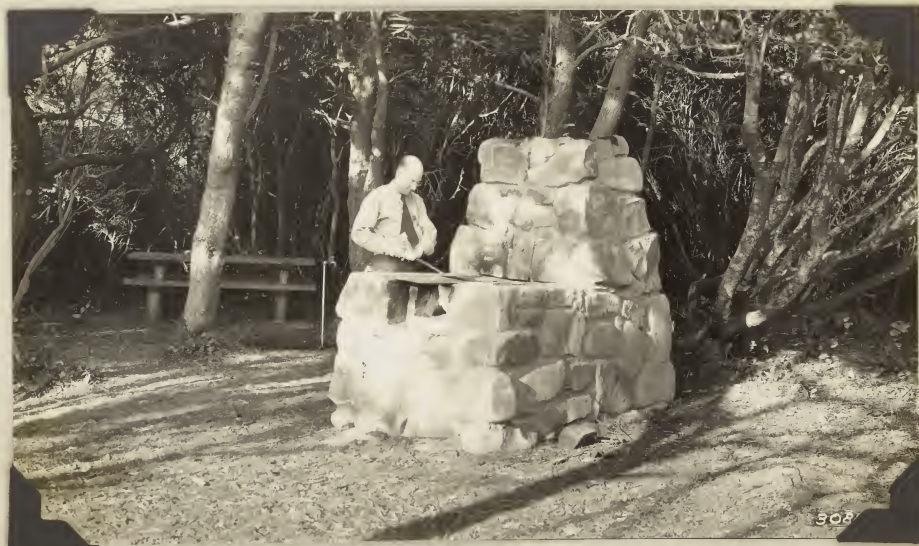
State Park at Newport, Oregon

Detail of a picnic stove recently constructed in this area. Note that the stove has no door and no damper. The plate is easily removable. It is warped. The top of the plate is too high (approximately 3 feet above the ground). The stove is clumsy and not attractive or practical.

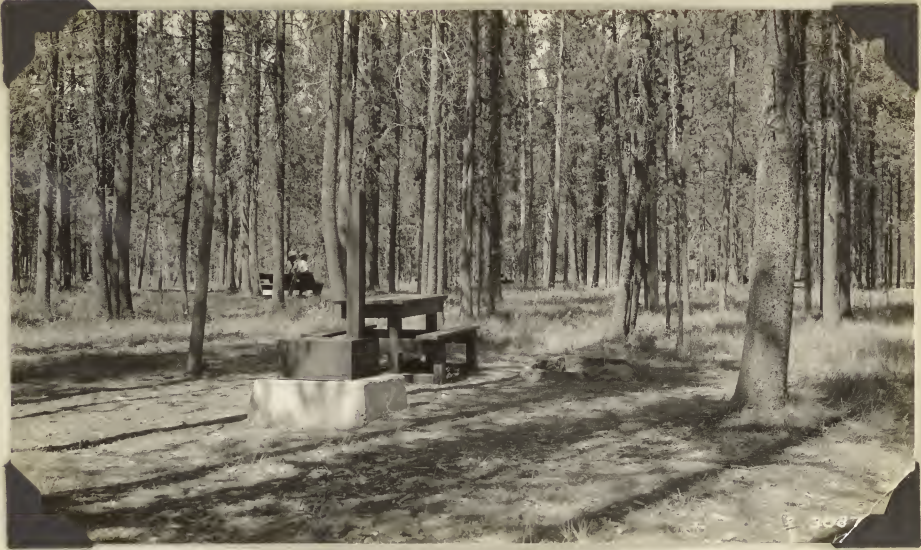
Targhee National Forest - Buffalo Forest Camp

General view of the camp ground showing the relationship of camp units to each other, and showing the interesting natural forest cover that has been preserved through the proper distribution of camp units. (Approximately 75 to 100 feet apart).

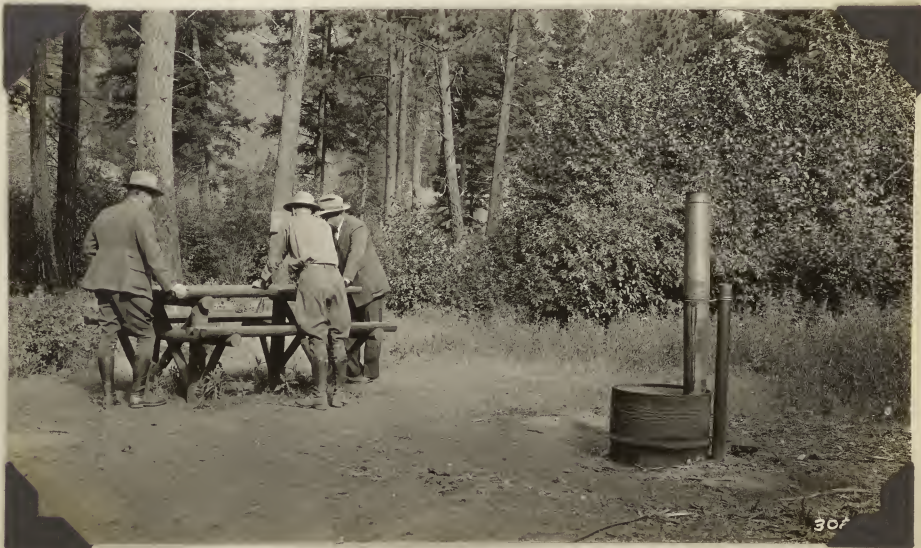
Lolo National Forest - Harry's Flat Forest Camp

General view showing a typical camp unit in this area. Note the stove, which is not appropriate for a forest area. This type of stove is a most detracting element in a forest camp. It should be entirely abandoned in favor of a more appropriate feature which fits into the atmosphere of the forest surroundings.

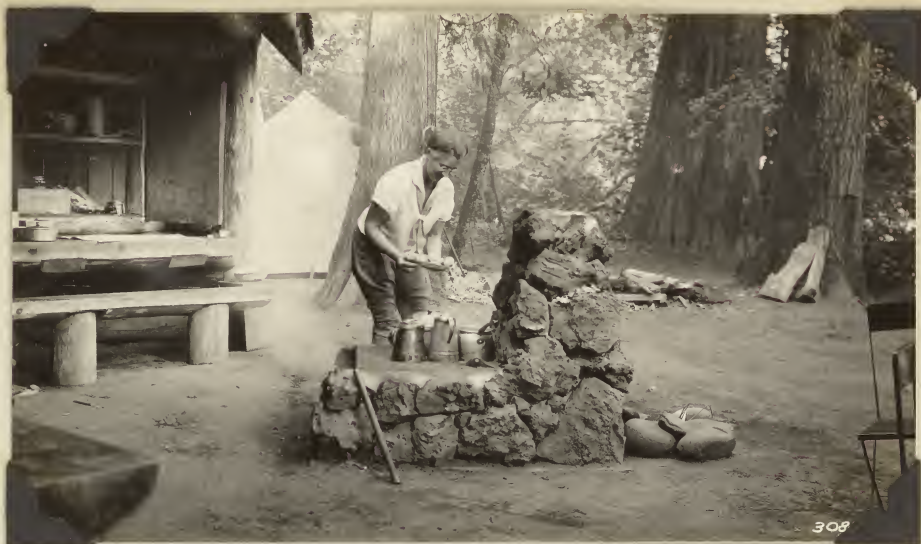
Willamette National Forest - McKenzie Bridge Forest Camp

Detail of a typical "permanent camp" with the evening meal in preparation. Note the typical fireplace which is used in this region. These permanent camp structures are very popular in the larger camp grounds.

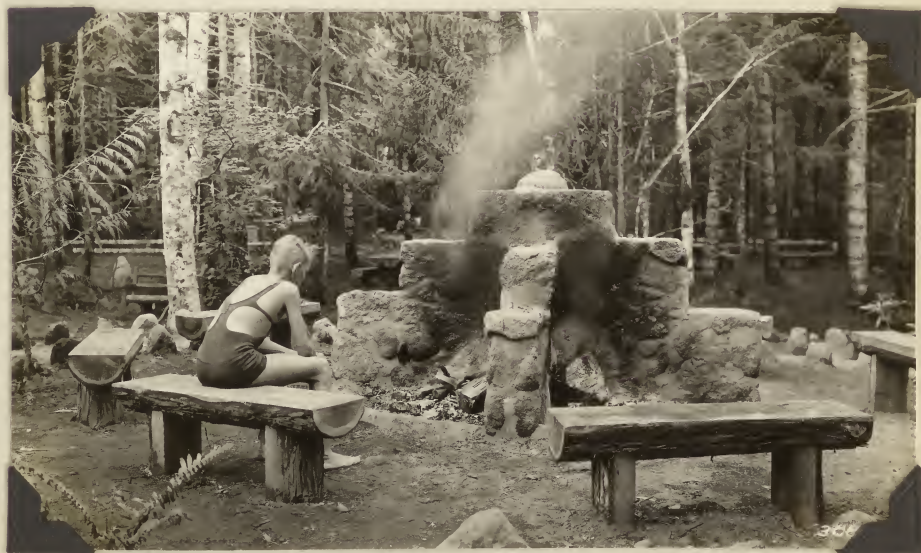
Mount Hood National Forest - Camp Creek Forest Camp

Detail view of a "warming" fire, showing a small boy sitting beside the fire warming himself after taking a swim in water with a temperature of approximately 58° . Note the interesting construction of the log seats.

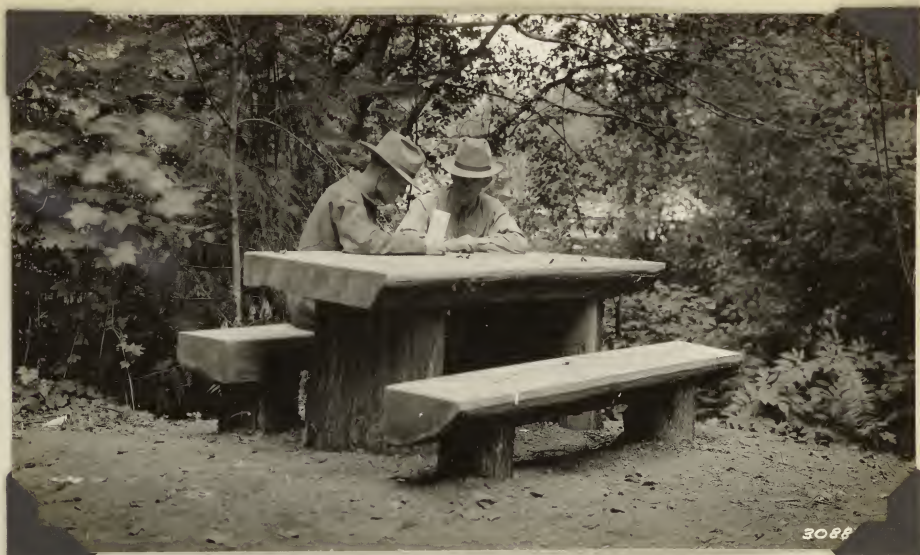
Olympic National Forest - Fall Creek Forest Camp

Detail showing a unique table with the top constructed of a single slab. This kind of construction is entirely practical in locations where the large timber grows.

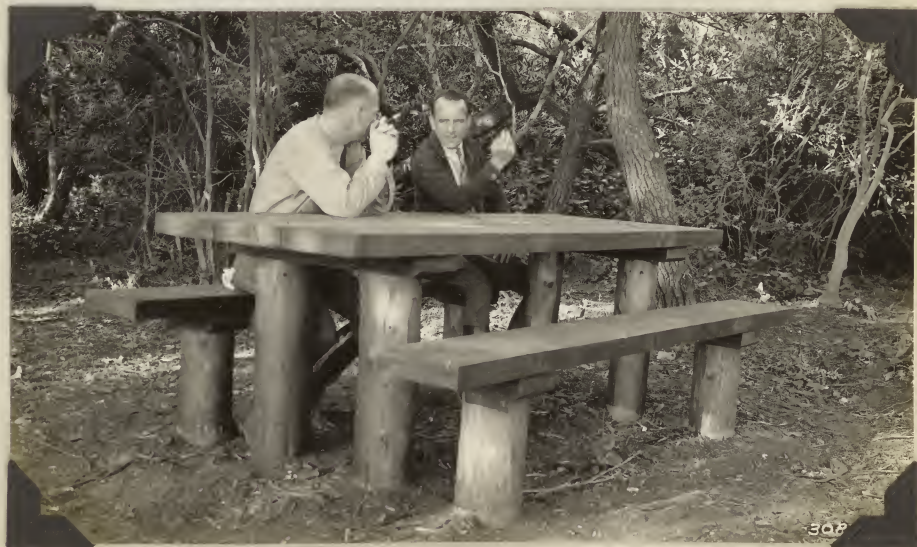
State Park at Newport, Oregon

Detail of picnic table used in this area. The seats (approximately 18" to 19" in height) are too high. The top of the seat should be approximately 15" to 16" for comfortable use.

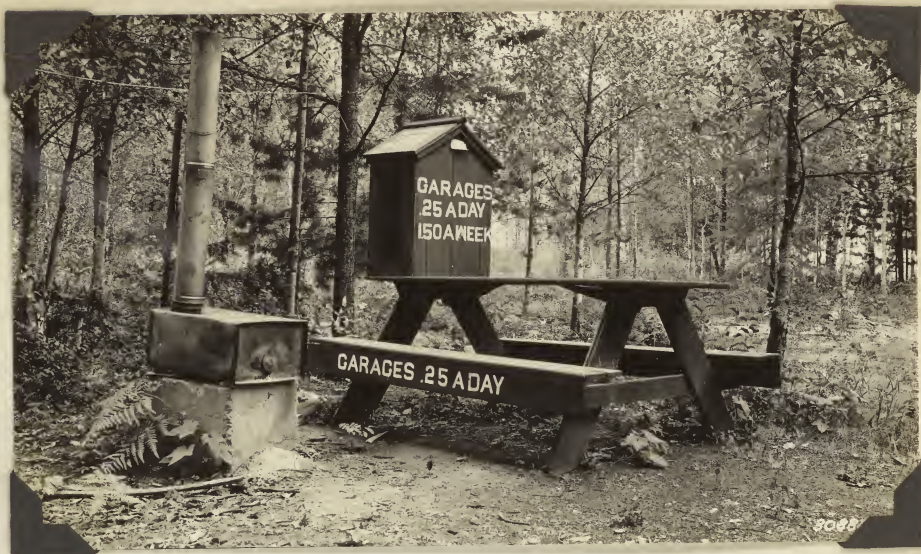
Kaniksu National Forest - Priest Lake Area

Detail photograph of picnic table, cupboard and stove in one of the privately owned picnic areas. This contains all of the elements which are not desirable in a camp ground and picnic area.

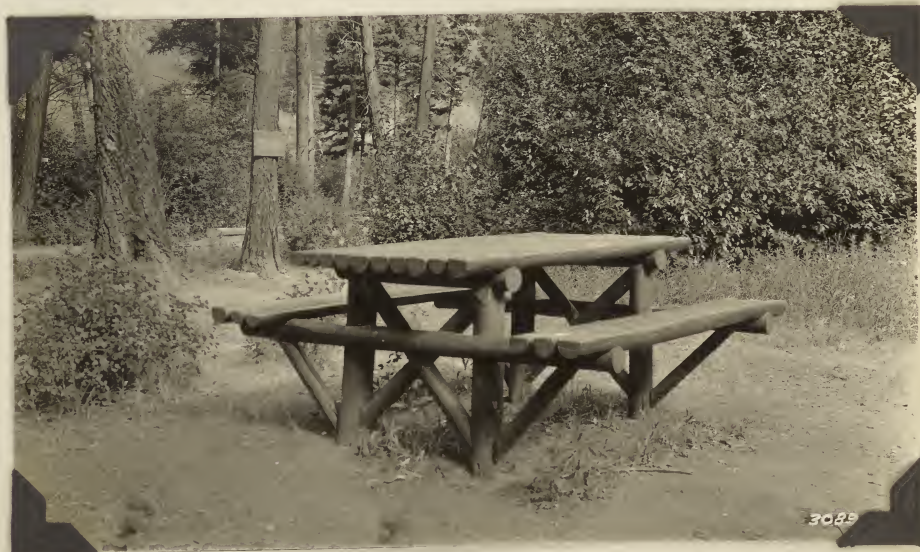
Lolo National Forest - Harry's Flat Forest Camp

Detail view of an interesting type of picnic table, constructed for use in this camp.

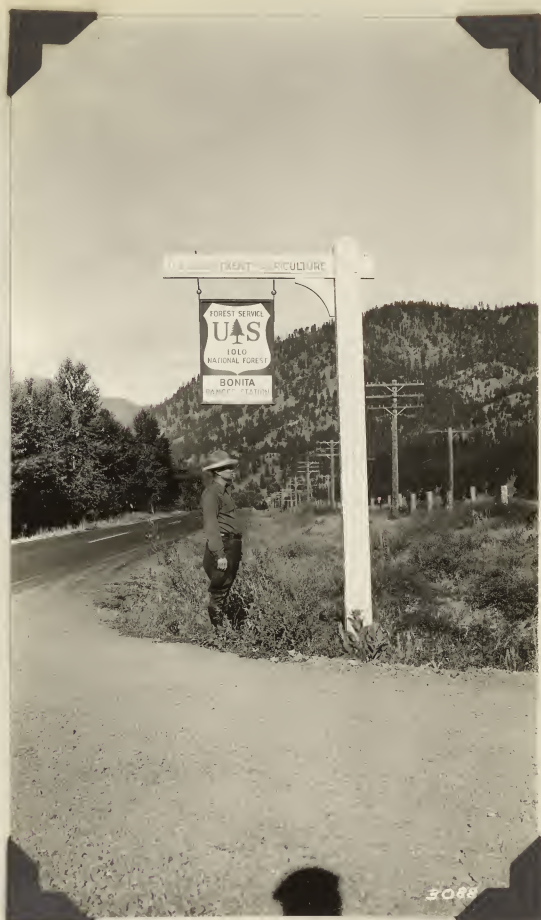
Lolo National Forest
Entrance Sign to Bonita Ranger Station

Detail view of the entrance sign which appears to be too high in its present setting. When the necessary grading and planting is completed around the base of this sign, the effect will be much improved.

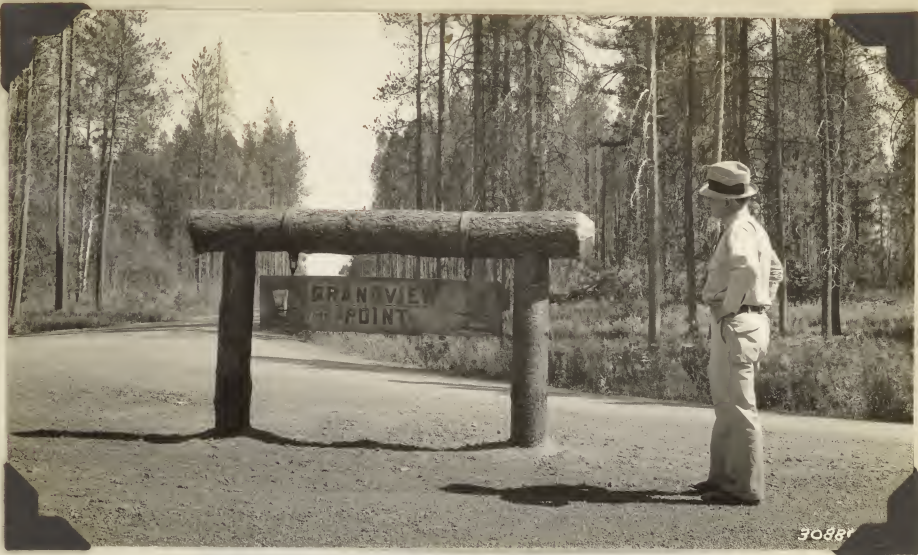
Targhee National Forest - Grandview Point (Direction Sign)

Detail of a typical entrance sign located in a triangular area at the intersection of the side road and the main forest highway. Triangular areas on which such signs are erected should be planted with a natural forest ground cover in order to give the signs a more attractive and natural setting. This sign in particular should be approximately 18 inches higher than it now stands.

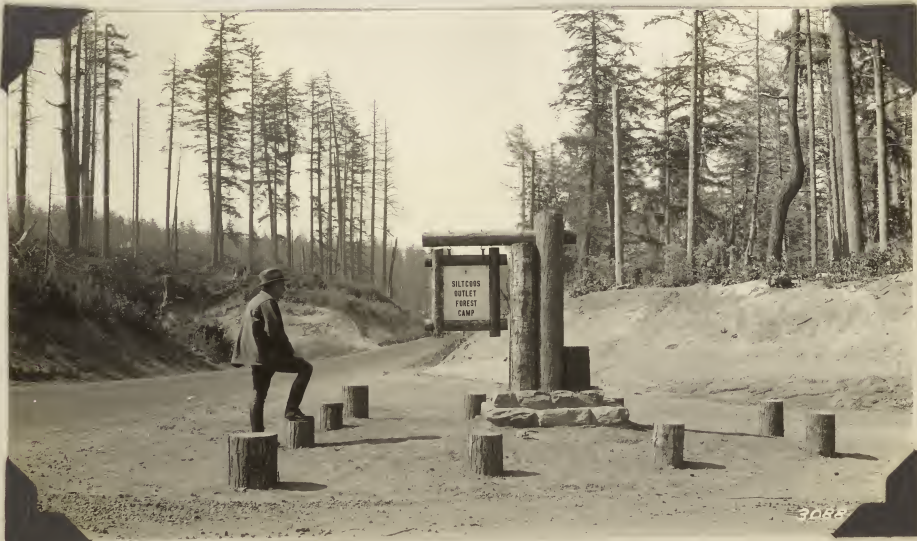
Siuslaw National Forest - Siltcoos Outlet Forest Camp

Detail view showing entrance sign for these camp grounds. This sign is approximately 15 inches too low. The area surrounding this sign should be planted with appropriate native ground cover, and the sand bank should be planted with Holland grass. (See photographs Nos. 308854 and 308855, page 108).

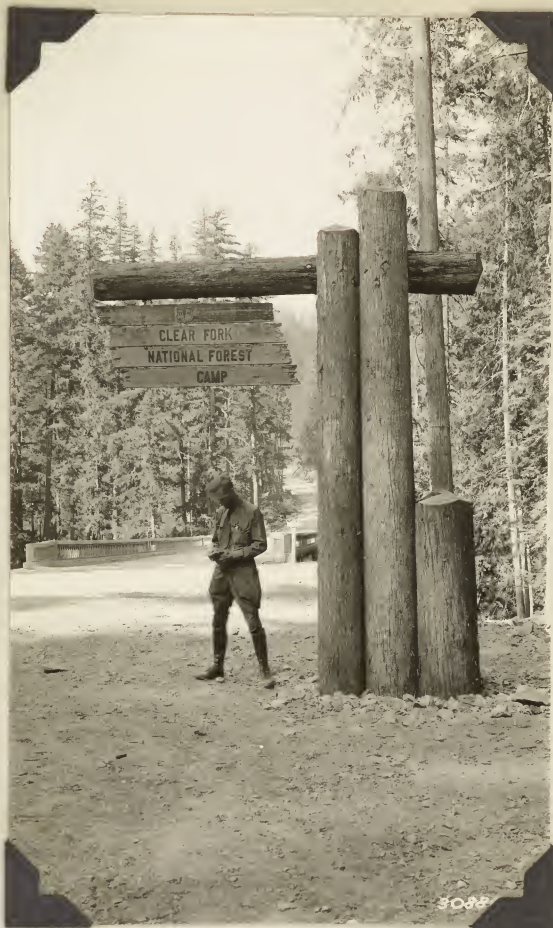
Columbia National Forest
Clear Fork Forest Camp

Detail view of the sign designating the entrance to the camp ground. This is a very appropriate sign. Note the absence of the usual pile of boulders around the base of this sign. This area should be planted with a ground cover of native material in order to improve the setting in which the sign is located.

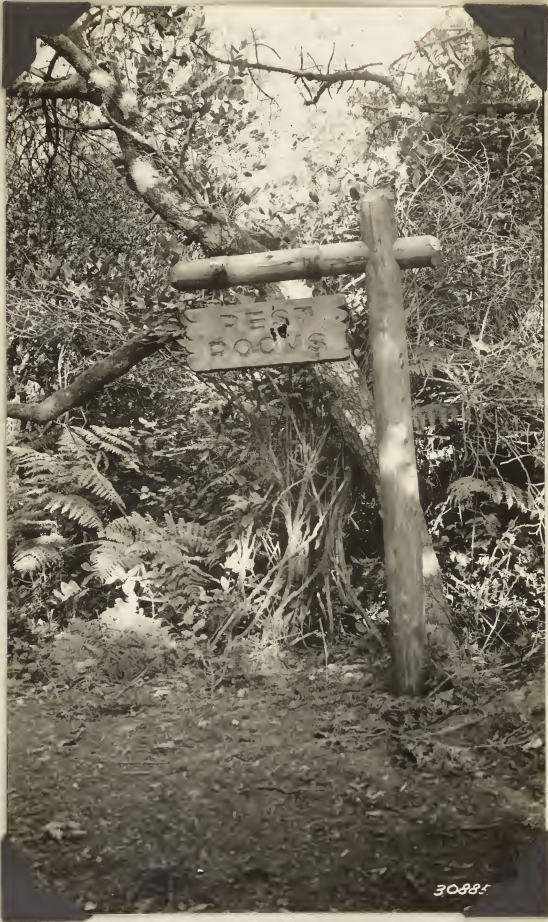
State Park at Newport, Oregon

Detail of a most attractive direction sign used in this area. This type of sign could be copied to excellent advantage in some of the National Forest camps.

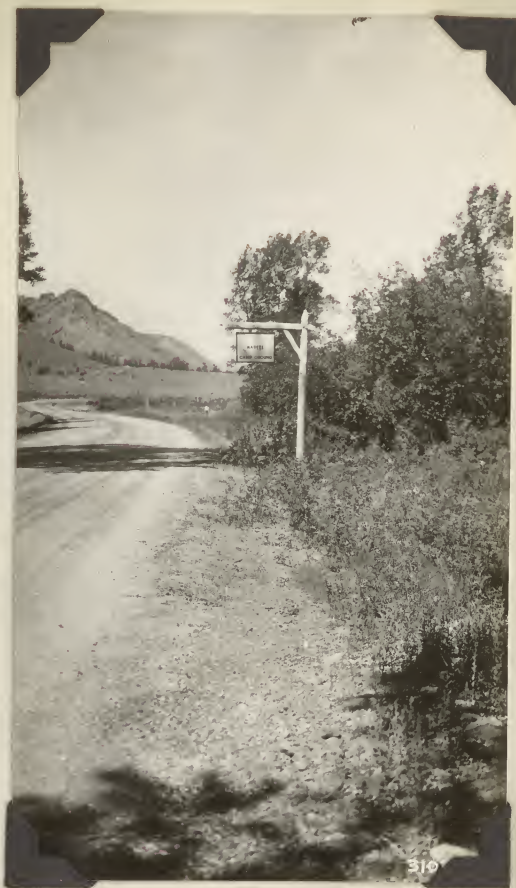
Camp Ground Sign

If this type of camp ground sign is to be used, this design is more preferable than the design shown in photograph No. 310376.

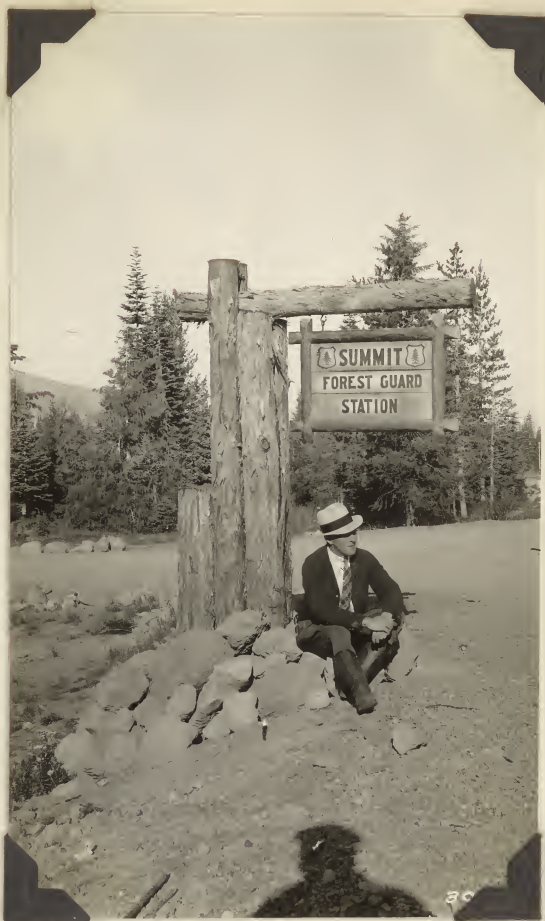
Mount Hood National Forest
Summit Forest Guard Station

A detail view of the sign designating the station's name, and located on the main forest highway. It seems unnecessary to pile so many stones around the base of these signs, and it also seems desirable to raise their height and to use natural forest ground-cover around the base. The conception of this design is excellent.

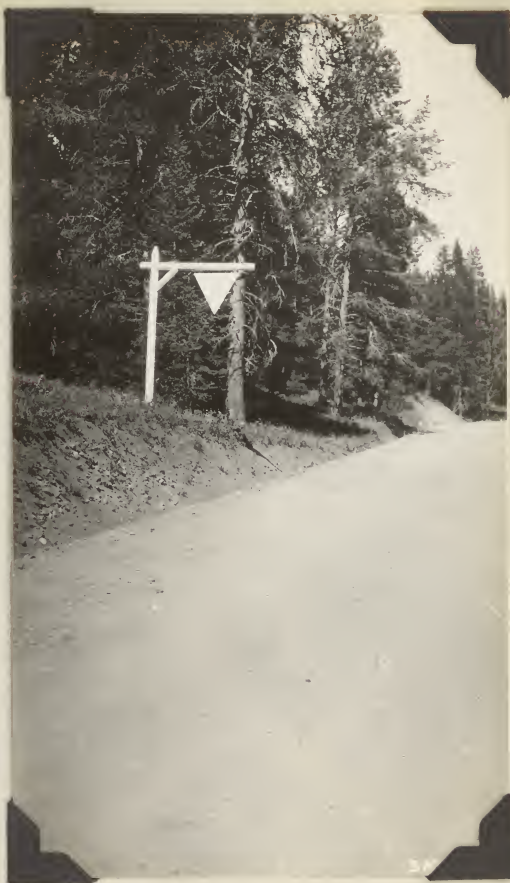
Camp Ground Sign

This type of camp ground sign ought to be discouraged for camp ground use in forest areas. It does not have good proportions. It presents an artificial and unnatural effect.

The sign shown in photograph No. 310376, (page 226) should be abandoned for use in the forest areas, and a sign similar to the one in photograph No. 308907, (page 227) should be adopted, with the color changed to a natural brown.

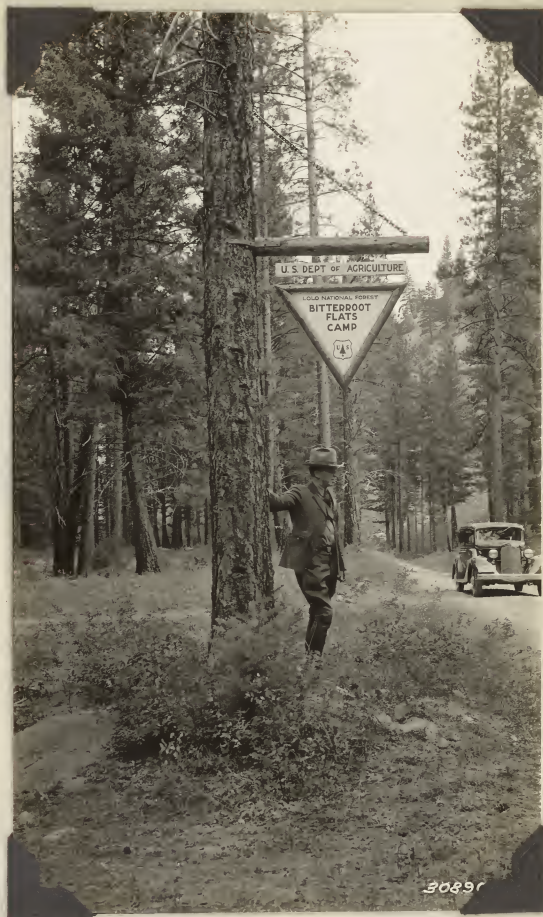
Lolo National Forest
Bitterroot Flats Forest Camp

Detail view of the sign used to designate the entrance to this camp ground area. This sign would be more appropriate if the background of the triangular portion were a natural light brown color.

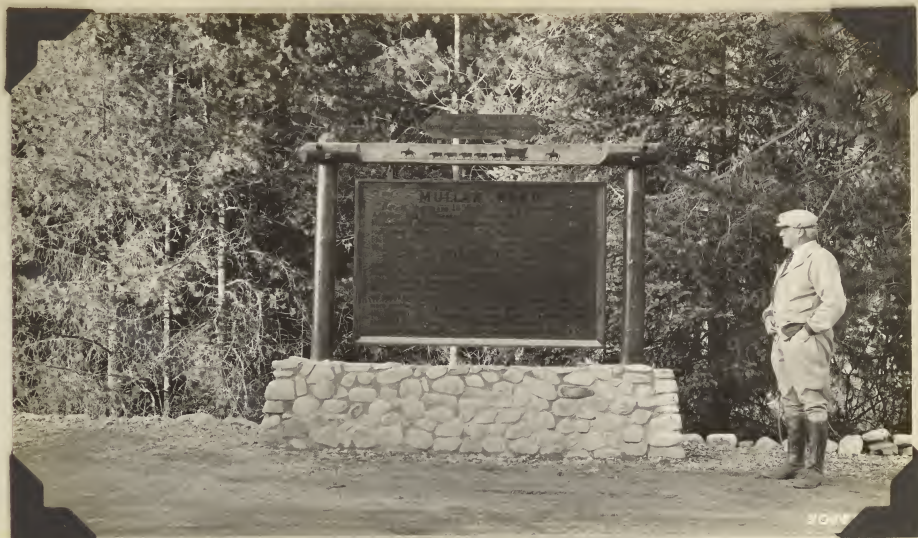
Cabinet National Forest

Detail view of the historic sign located on the Yellowstone Trail near Savenac, Montana. This is one of the very interesting signs which have been erected in numerous parts of the National Forests to convey information of historical value.

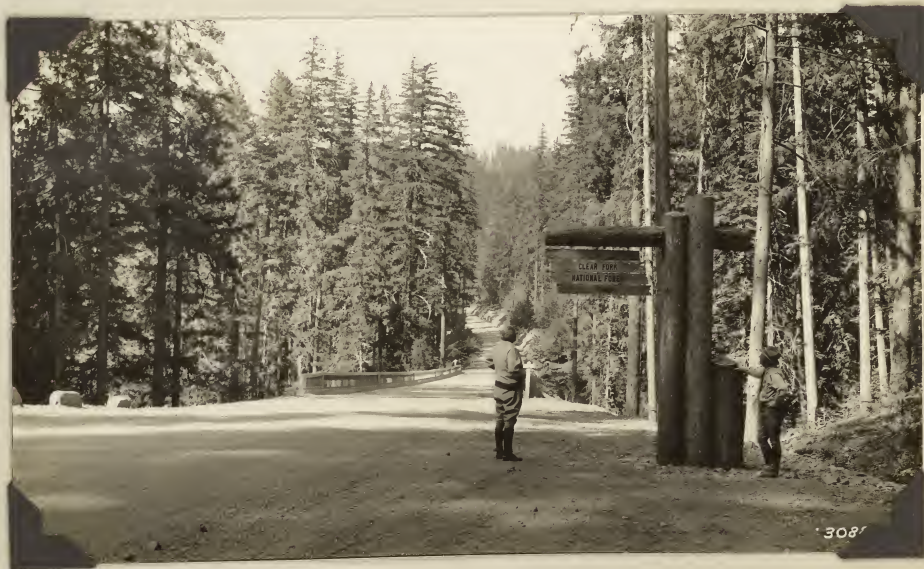
Columbia National Forest - Clear Fork Forest Camp

General view showing the location of the sign designating the entrance to the Clear Fork Forest Camp. The entrance to the camp ground is to the left of this picture. The main highway shows directly ahead. See also photograph No. 308864 (page 222).

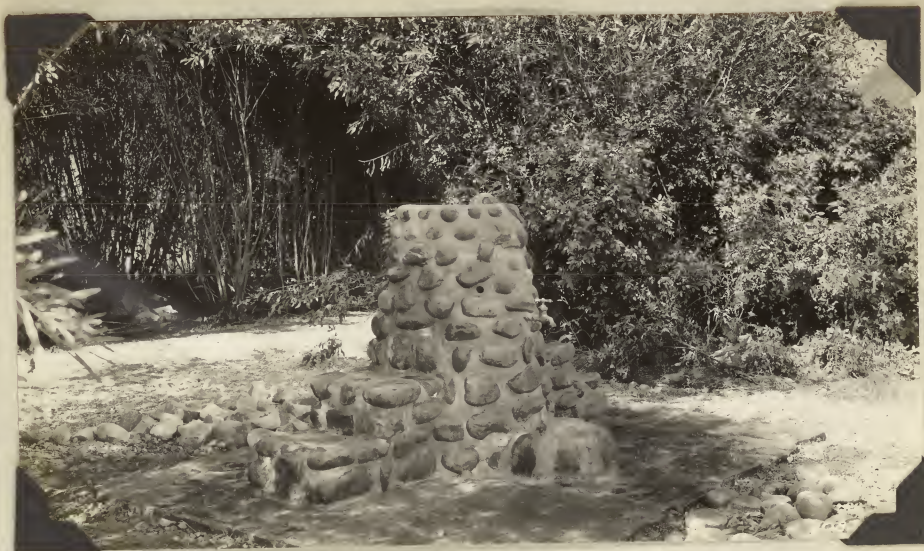
Cache National Forest - City Park Forest Camp

Detail view of an interesting drinking fountain developed as a source of water supply for the camp ground and picnic area. If this texture of stone work is to be used then there should be less exposure of stone in order to give a greater appearance of stability to this fountain. The individual stones might also be laid closer together.
